MISCELLANEOUS PAPER CERC-87-21

FLOATING TIRE BREAKWATER TESTS PICKERING BEACH, DELAWARE

Peter J. Grace, James E. Clausner

Coastal Engineering Research Center

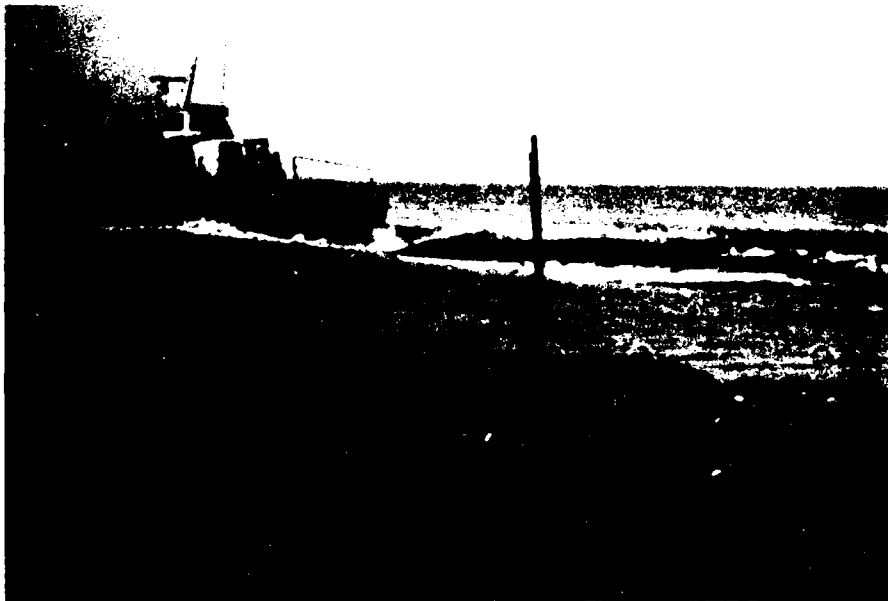
Figure 6. Boat wakes were generated by
the "Delaware"

27. During testing, all boat wakes were generated by the "Delaware," a 1969 Breaux Bay Craft crew boat, owned by the State of Delaware (Figure 6). The "Delaware" is an aluminum hull vessel powered by two GM 871 diesel engines and twin screw propulsion. It is 46 ft long and has a 17-ft beam, 3-ft 8-in. draft, and a 20-ton displacement. Maximum obtainable speed was 26 knots.
